08 Civ 5220 (DLC) (FM)

DECLARATION OF STEPHEN SPAULDING

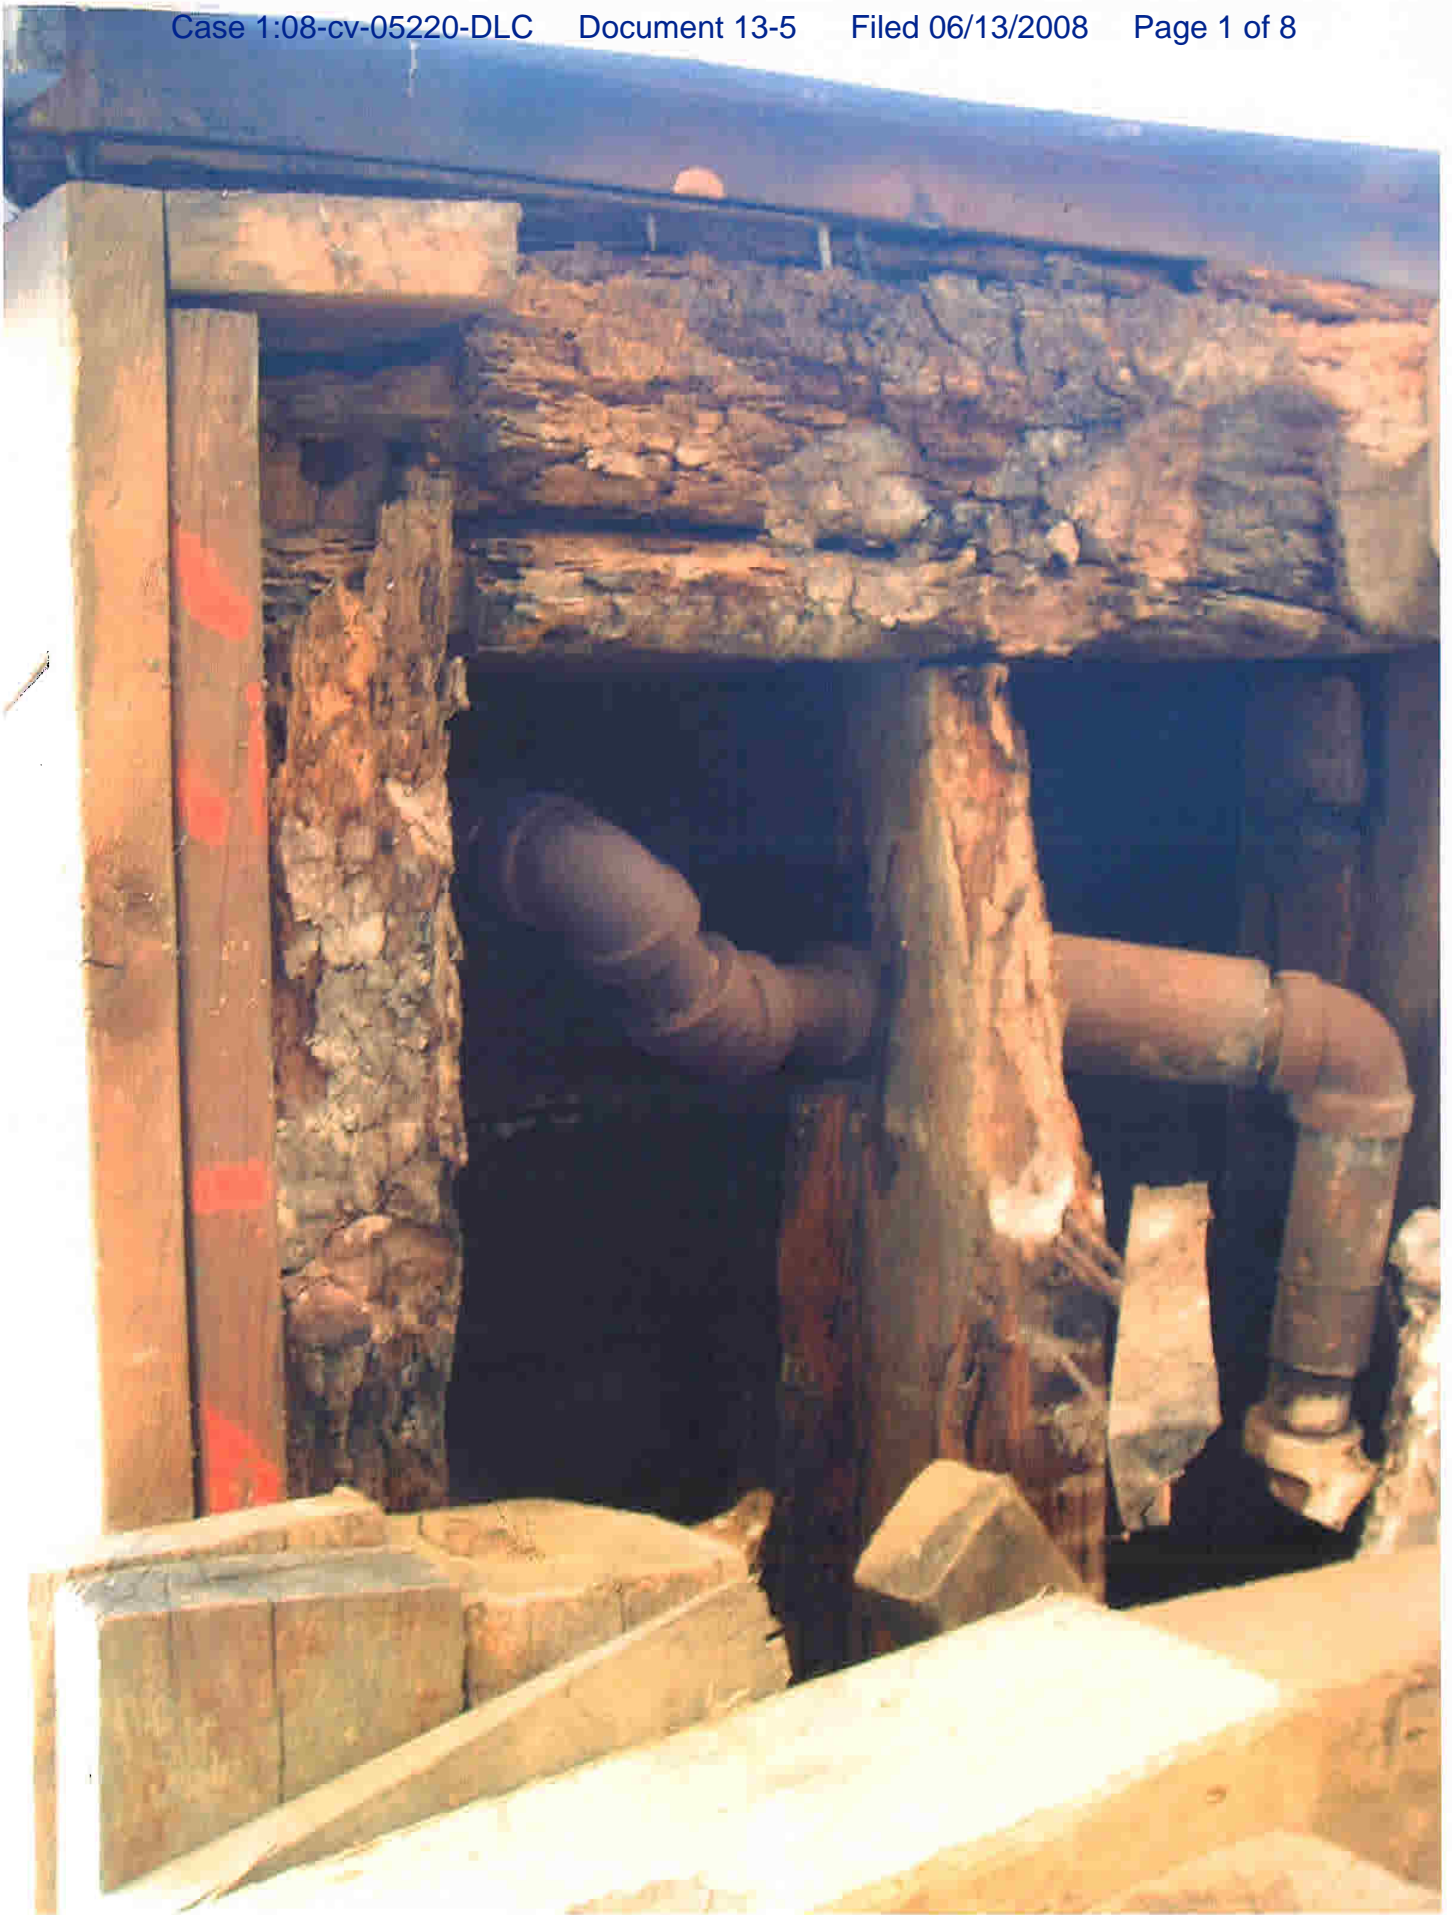
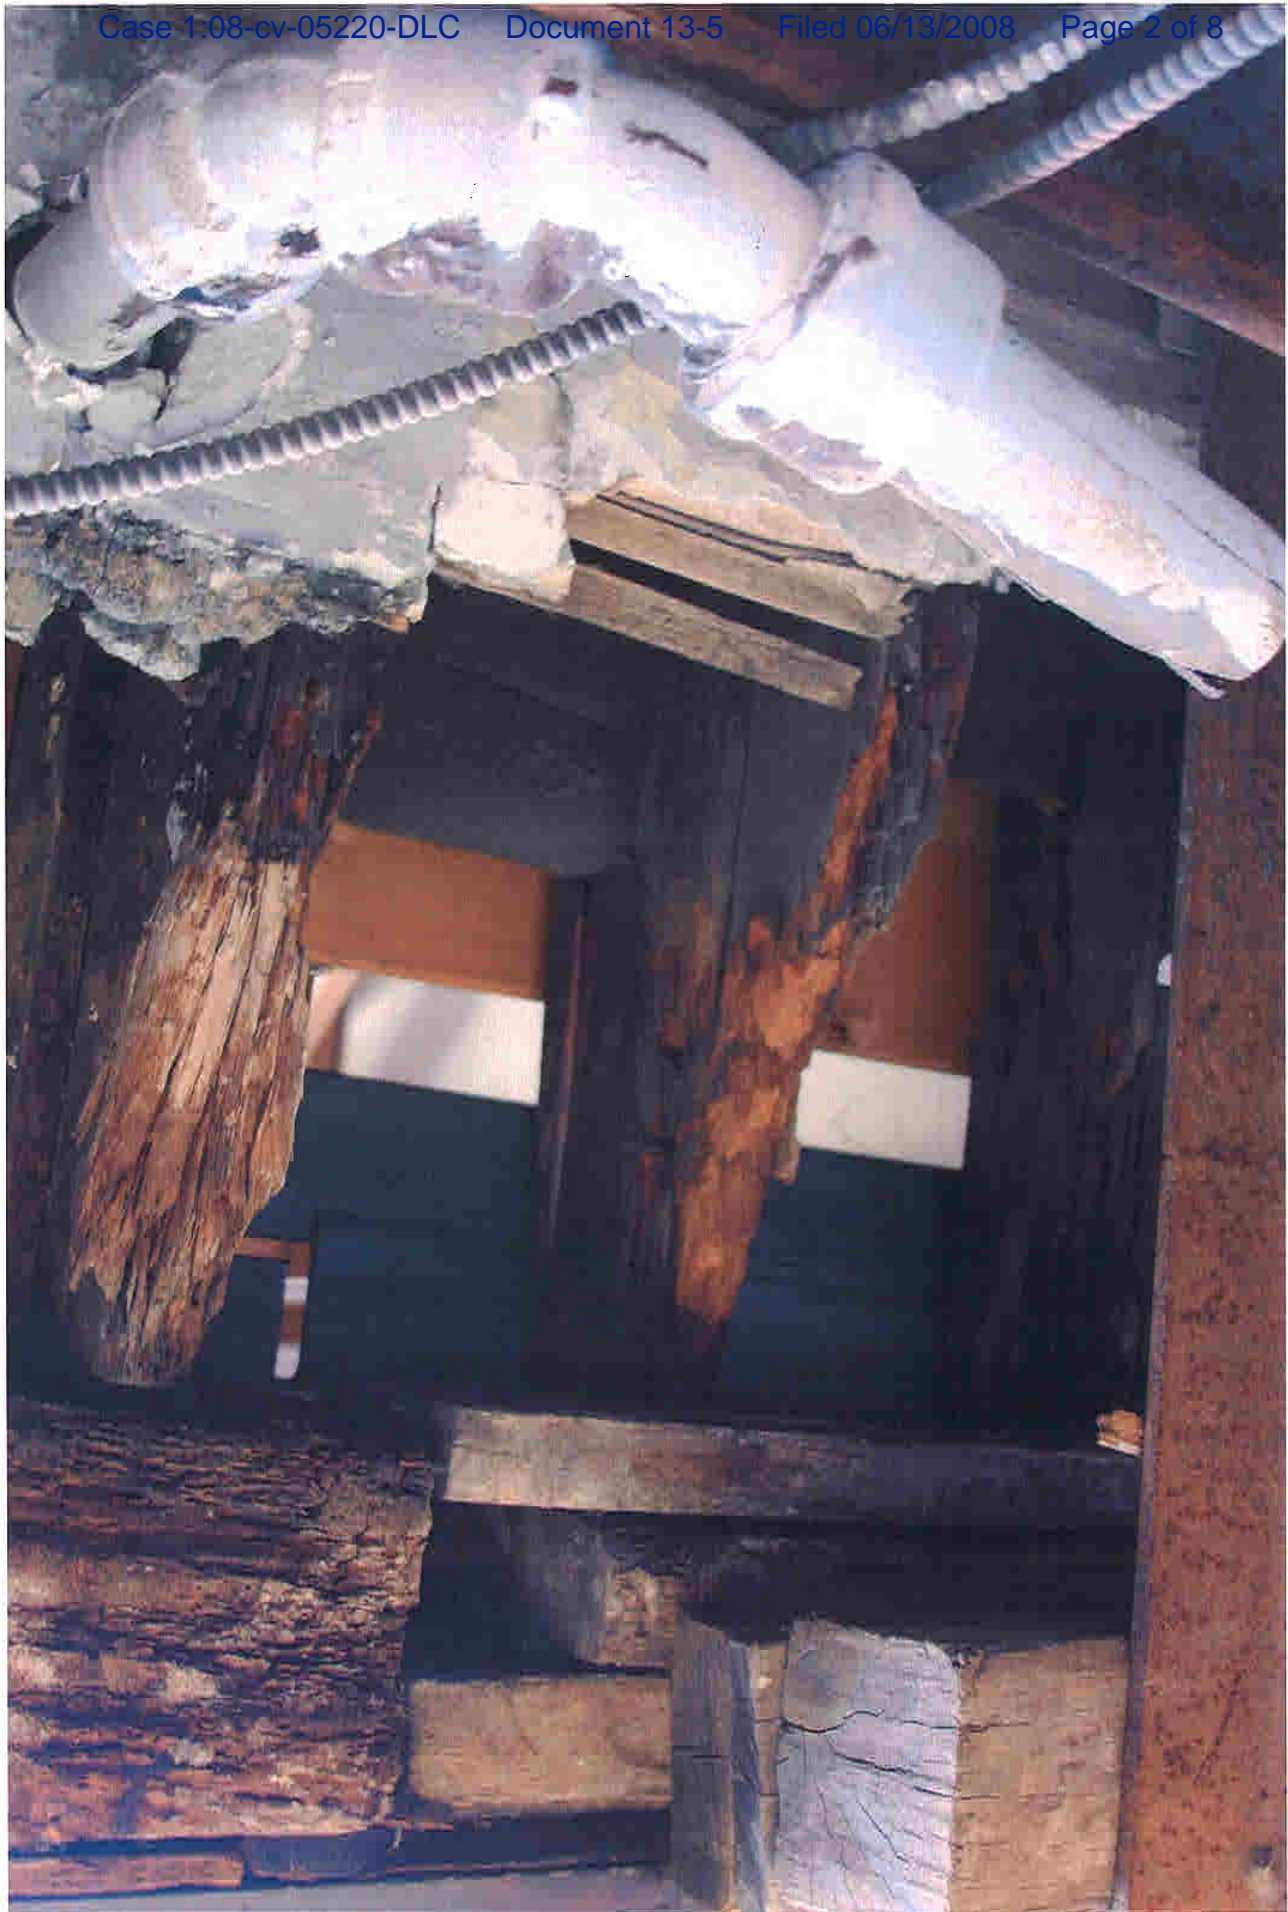
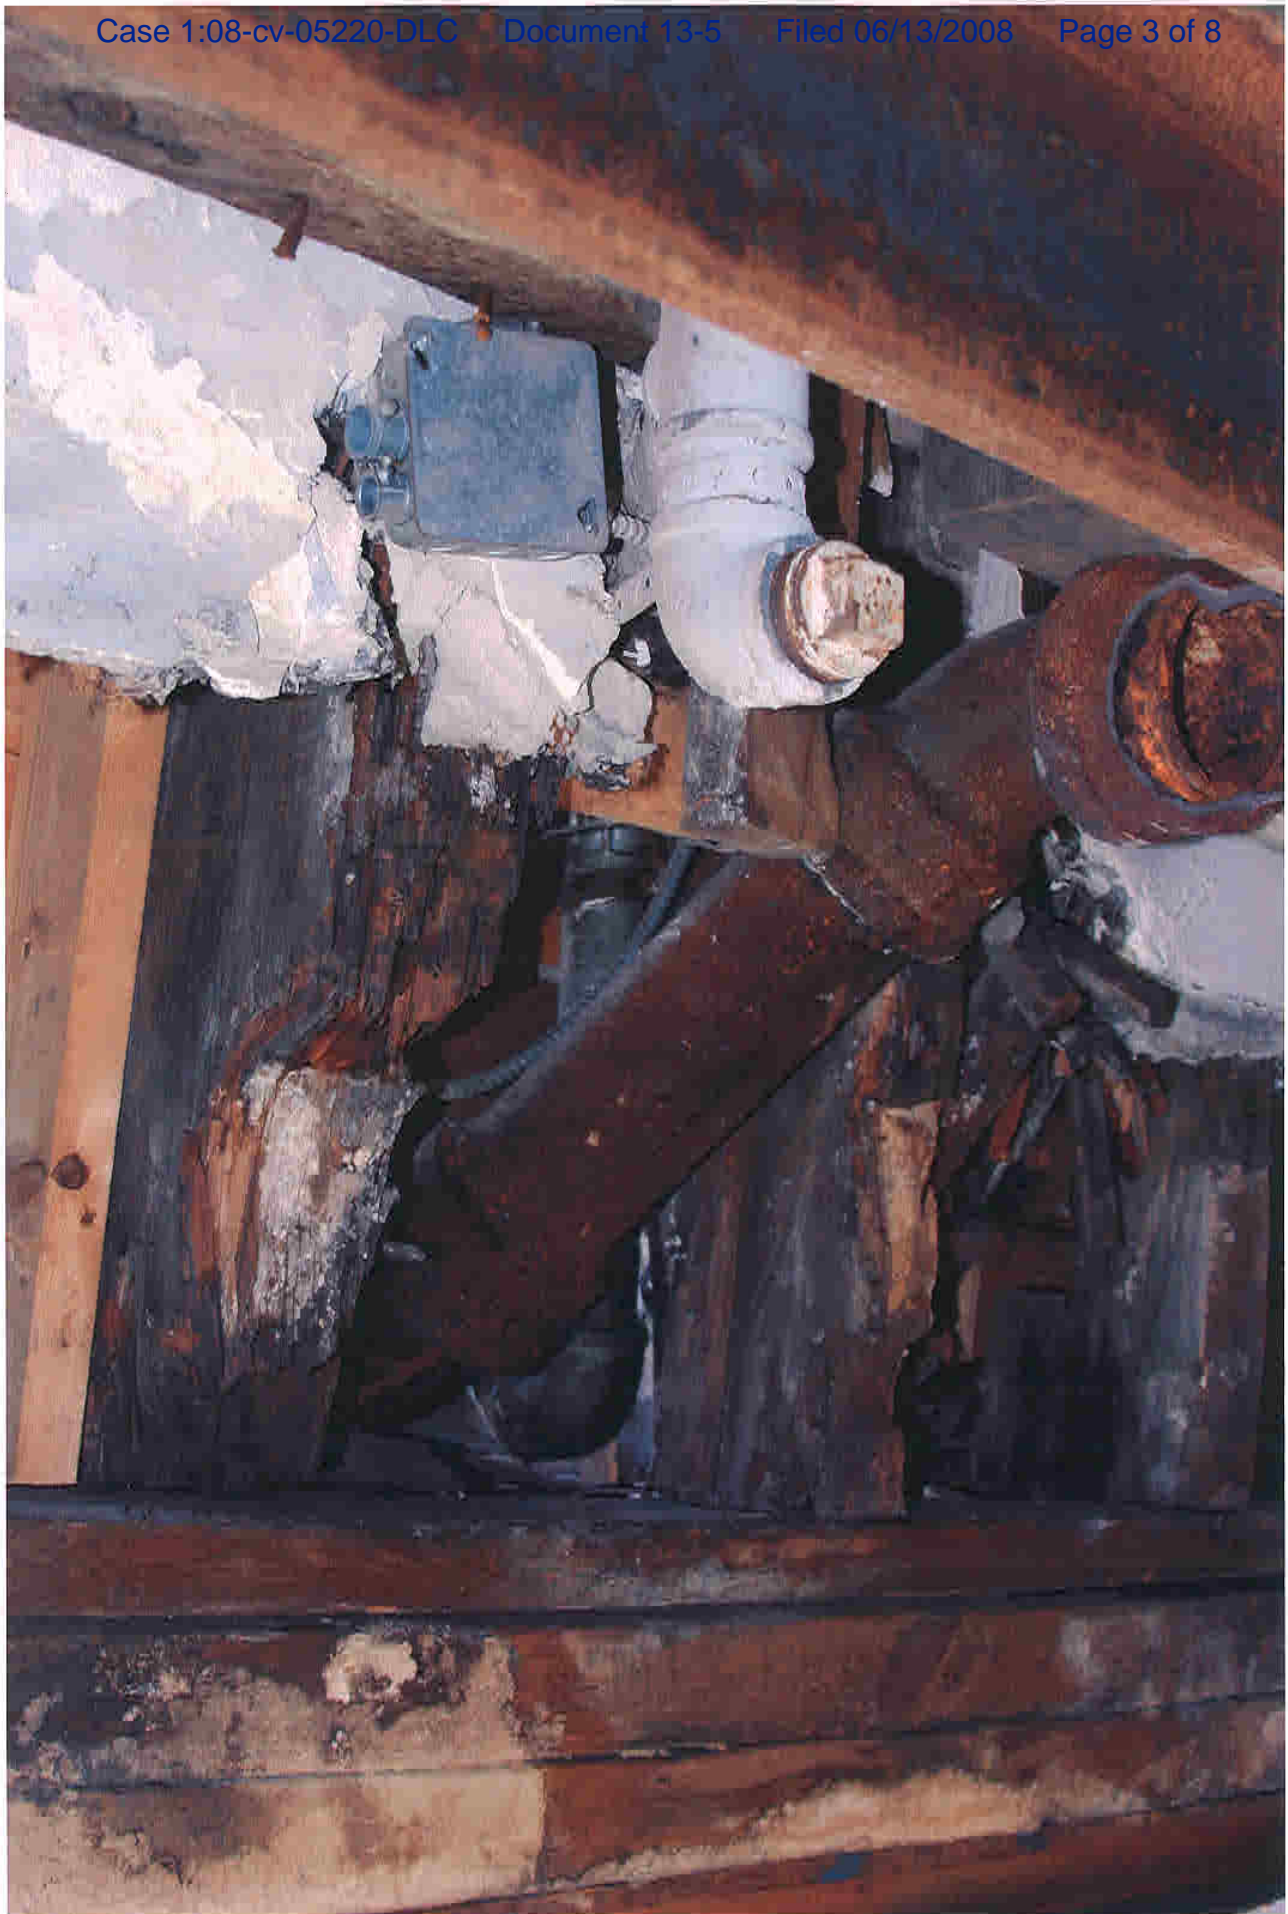
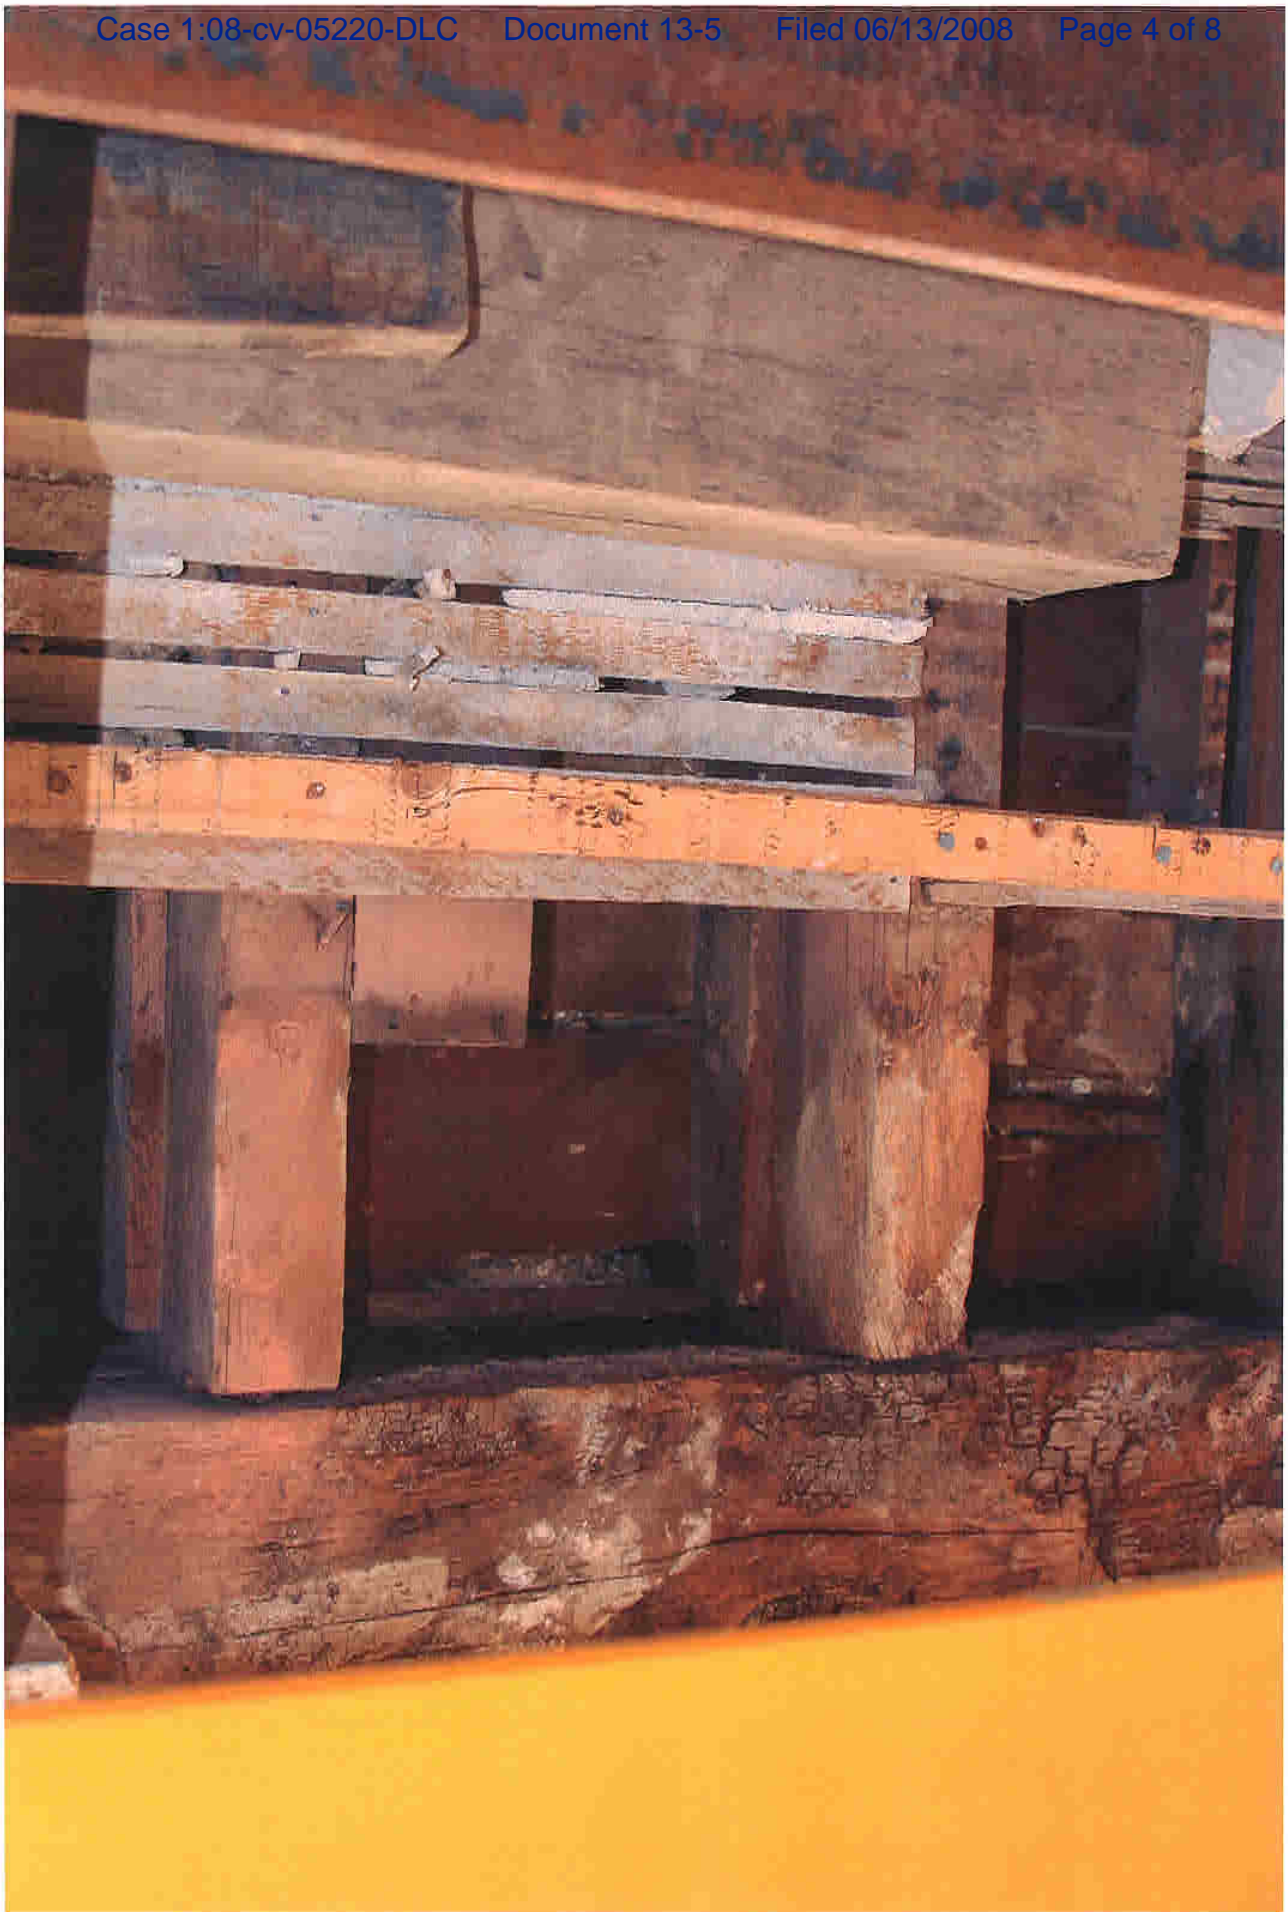
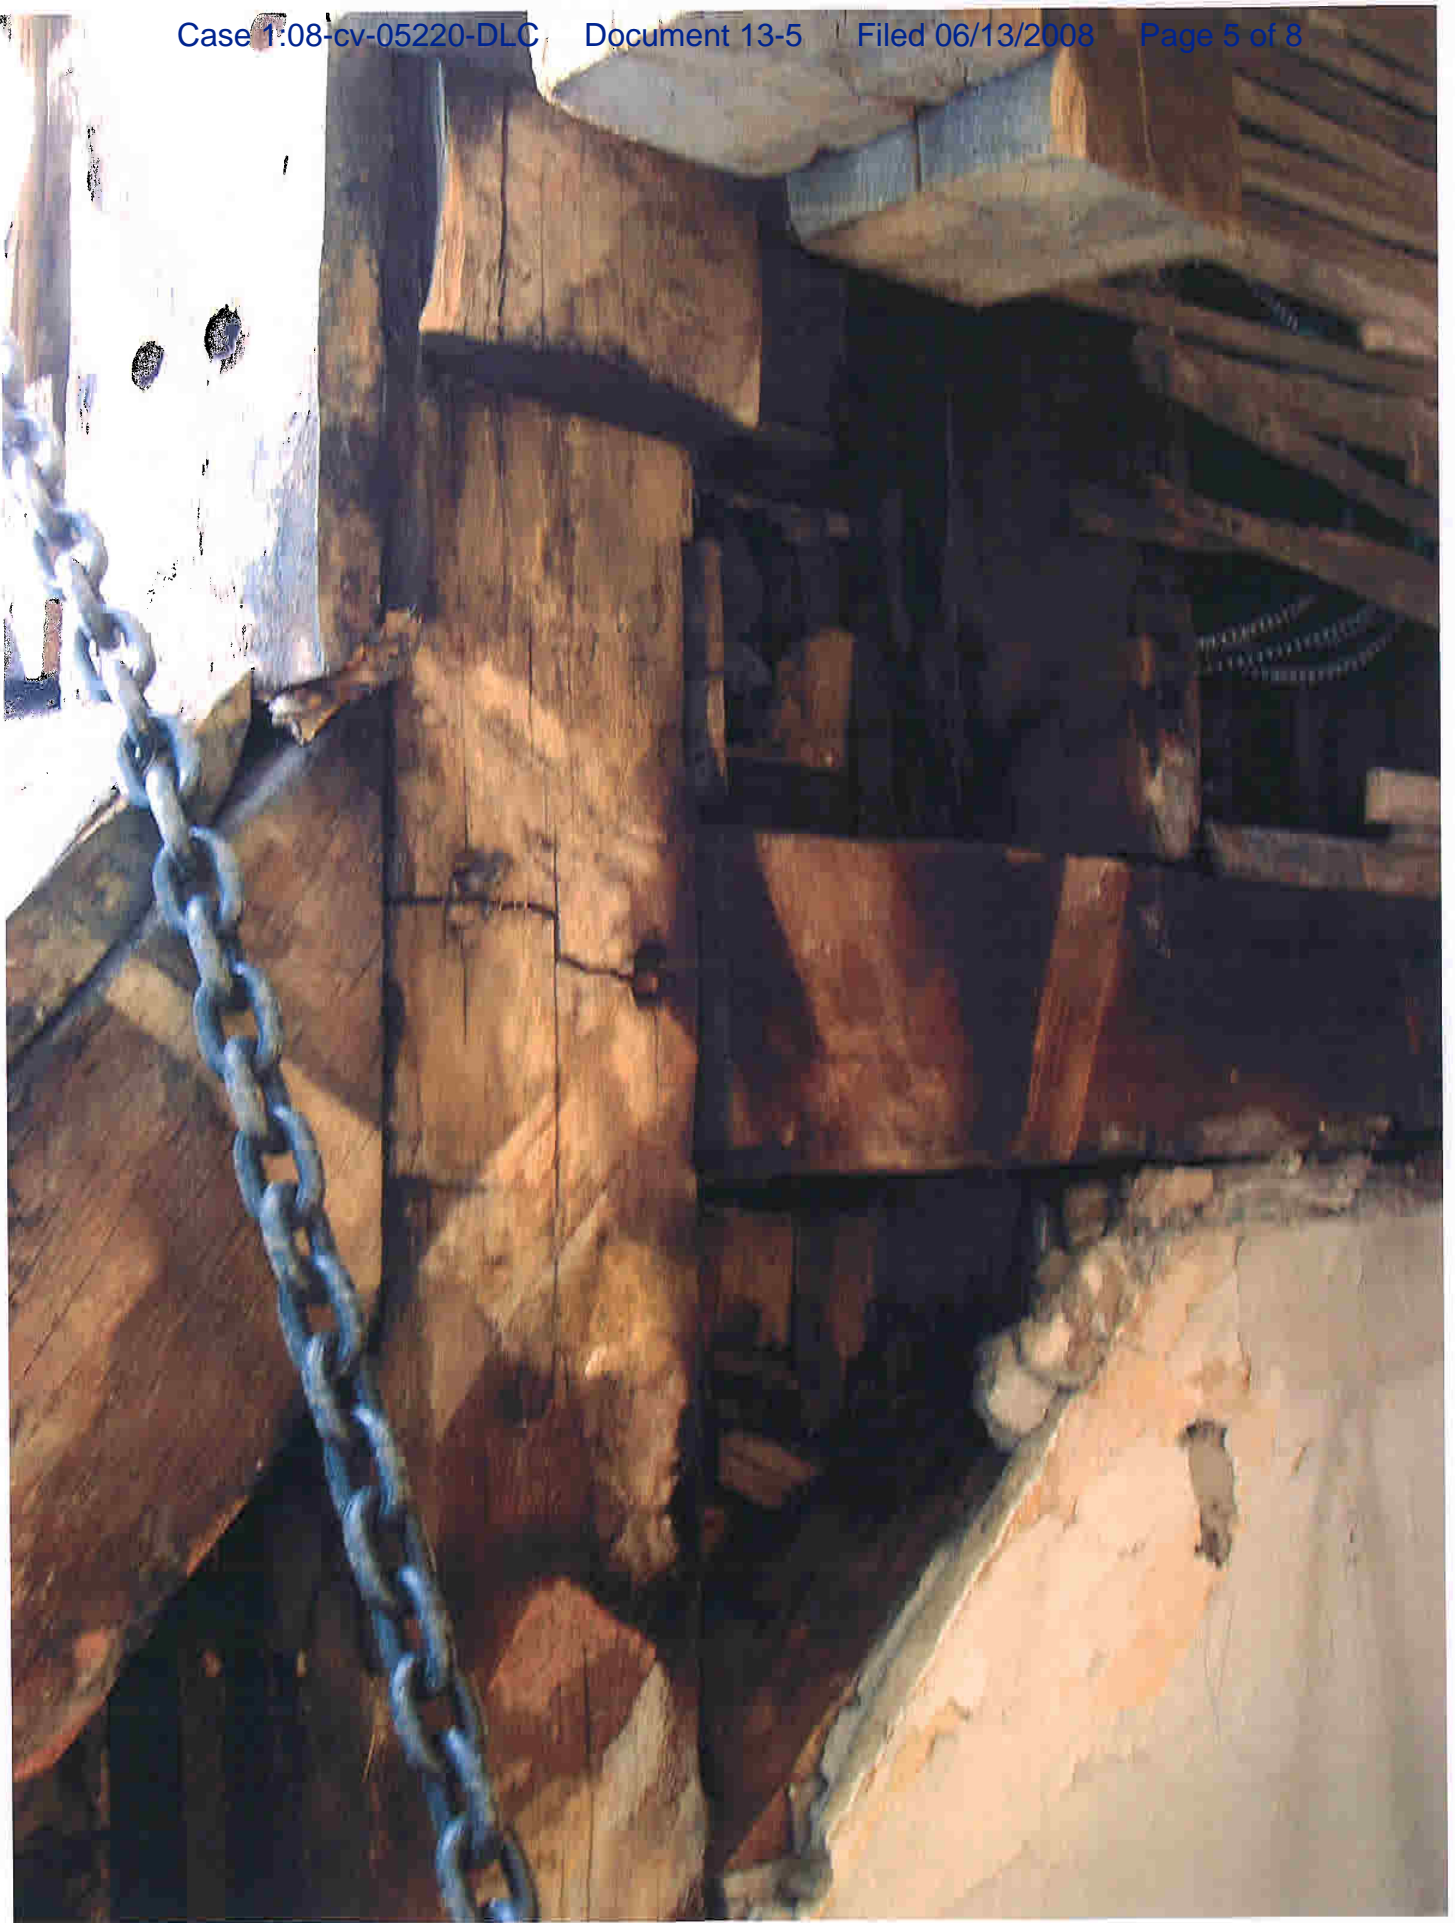
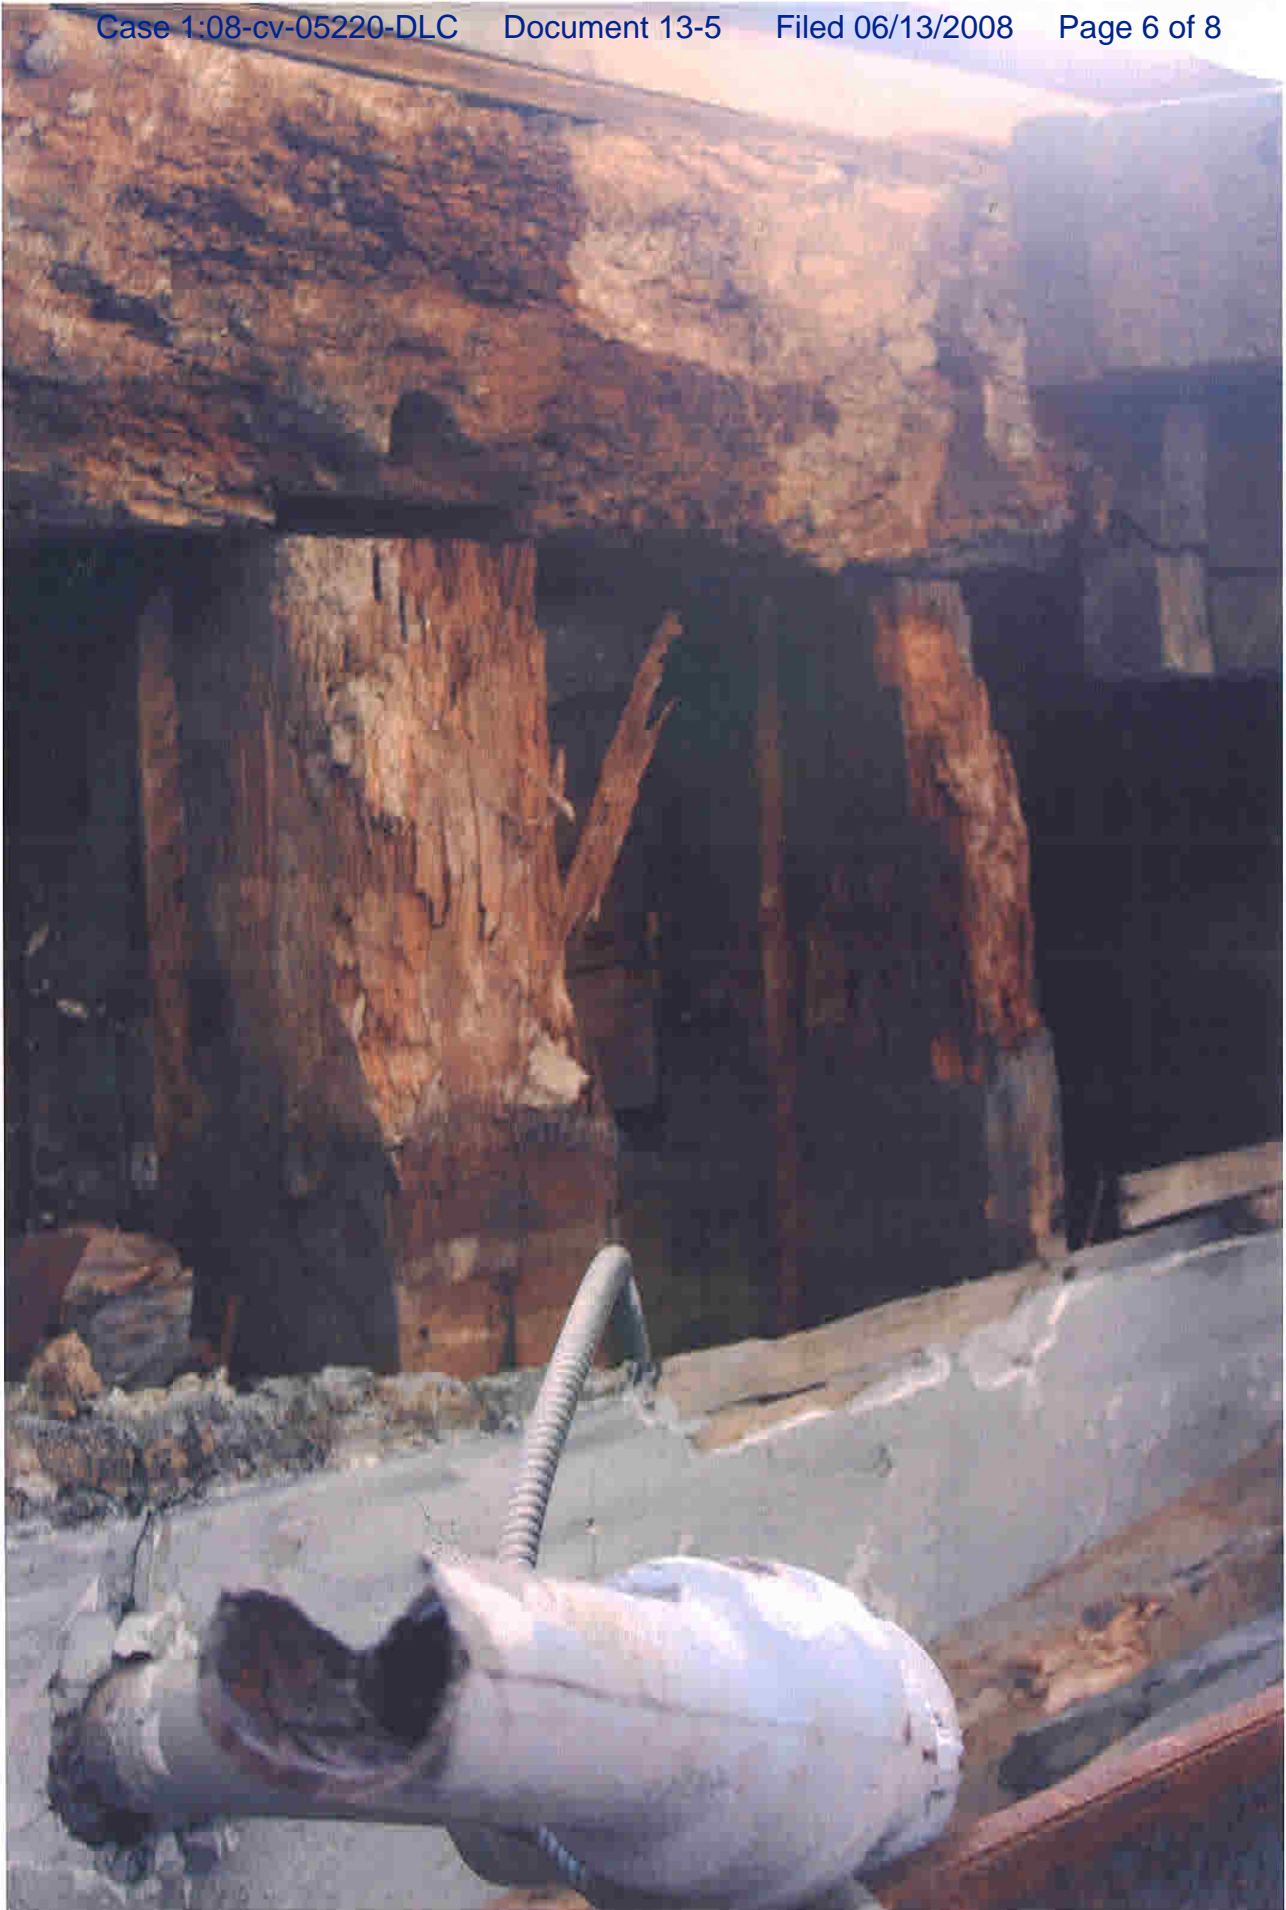
12. The Grange is also at risk because there is a significant amount of rot and decay damage to the wooden structure of the house, including the sills (wooden beams that support the frame of the house) and joists (horizontal wooden supports attached to the sills). Photographs attached as Exhibit 4 and bearing labels USA 26-28; 31; 34; 37-38 show several locations of damage to these wooden supports. The photograph labeled USA 29 shows undamaged sill and joist connections. The other photographs show varying degrees of damage to the wooden supports. In some locations, such as the one shown in USA 31, the sill has split completely. It is no longer providing adequate support to the structure above. While the Grange remains on its temporary foundation, these beams are exposed to the elements, exacerbating the damage and

decay. The Grange must be moved onto its permanent foundation so that repairs can be made to these damaged wooden structures and adequate support provided to the historic fabric above.

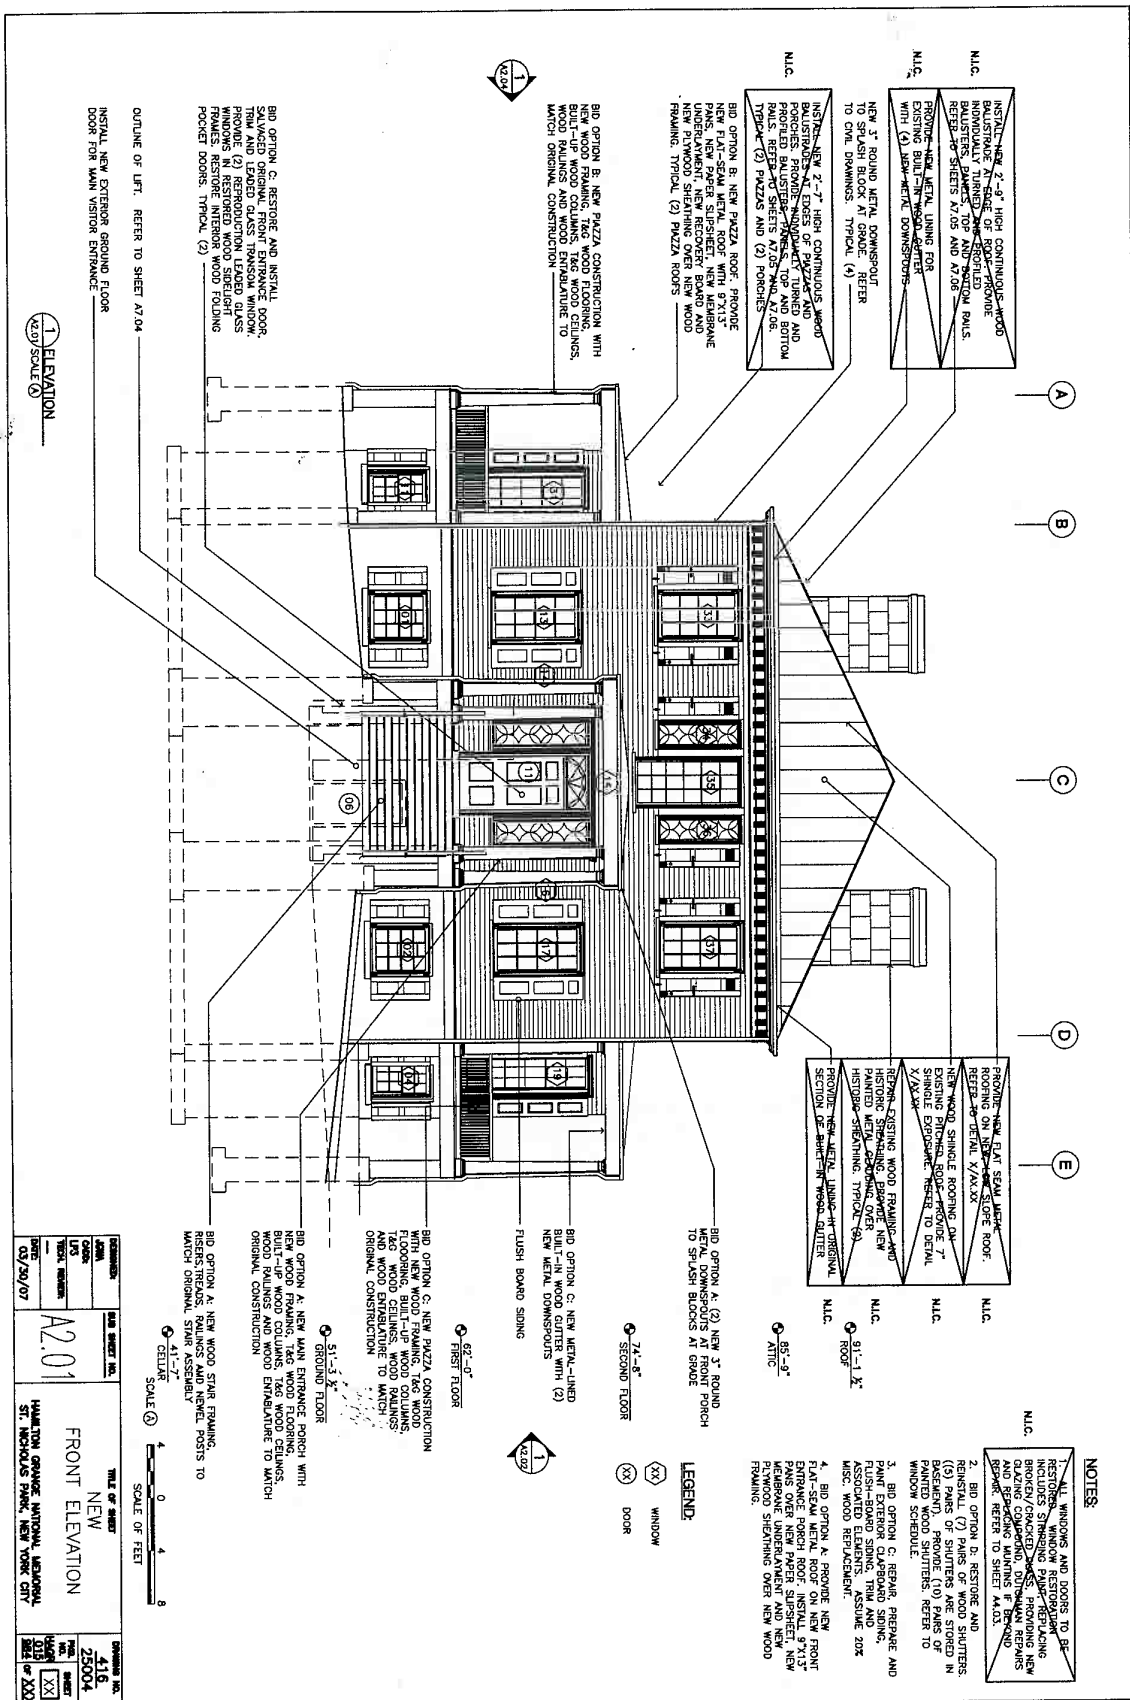
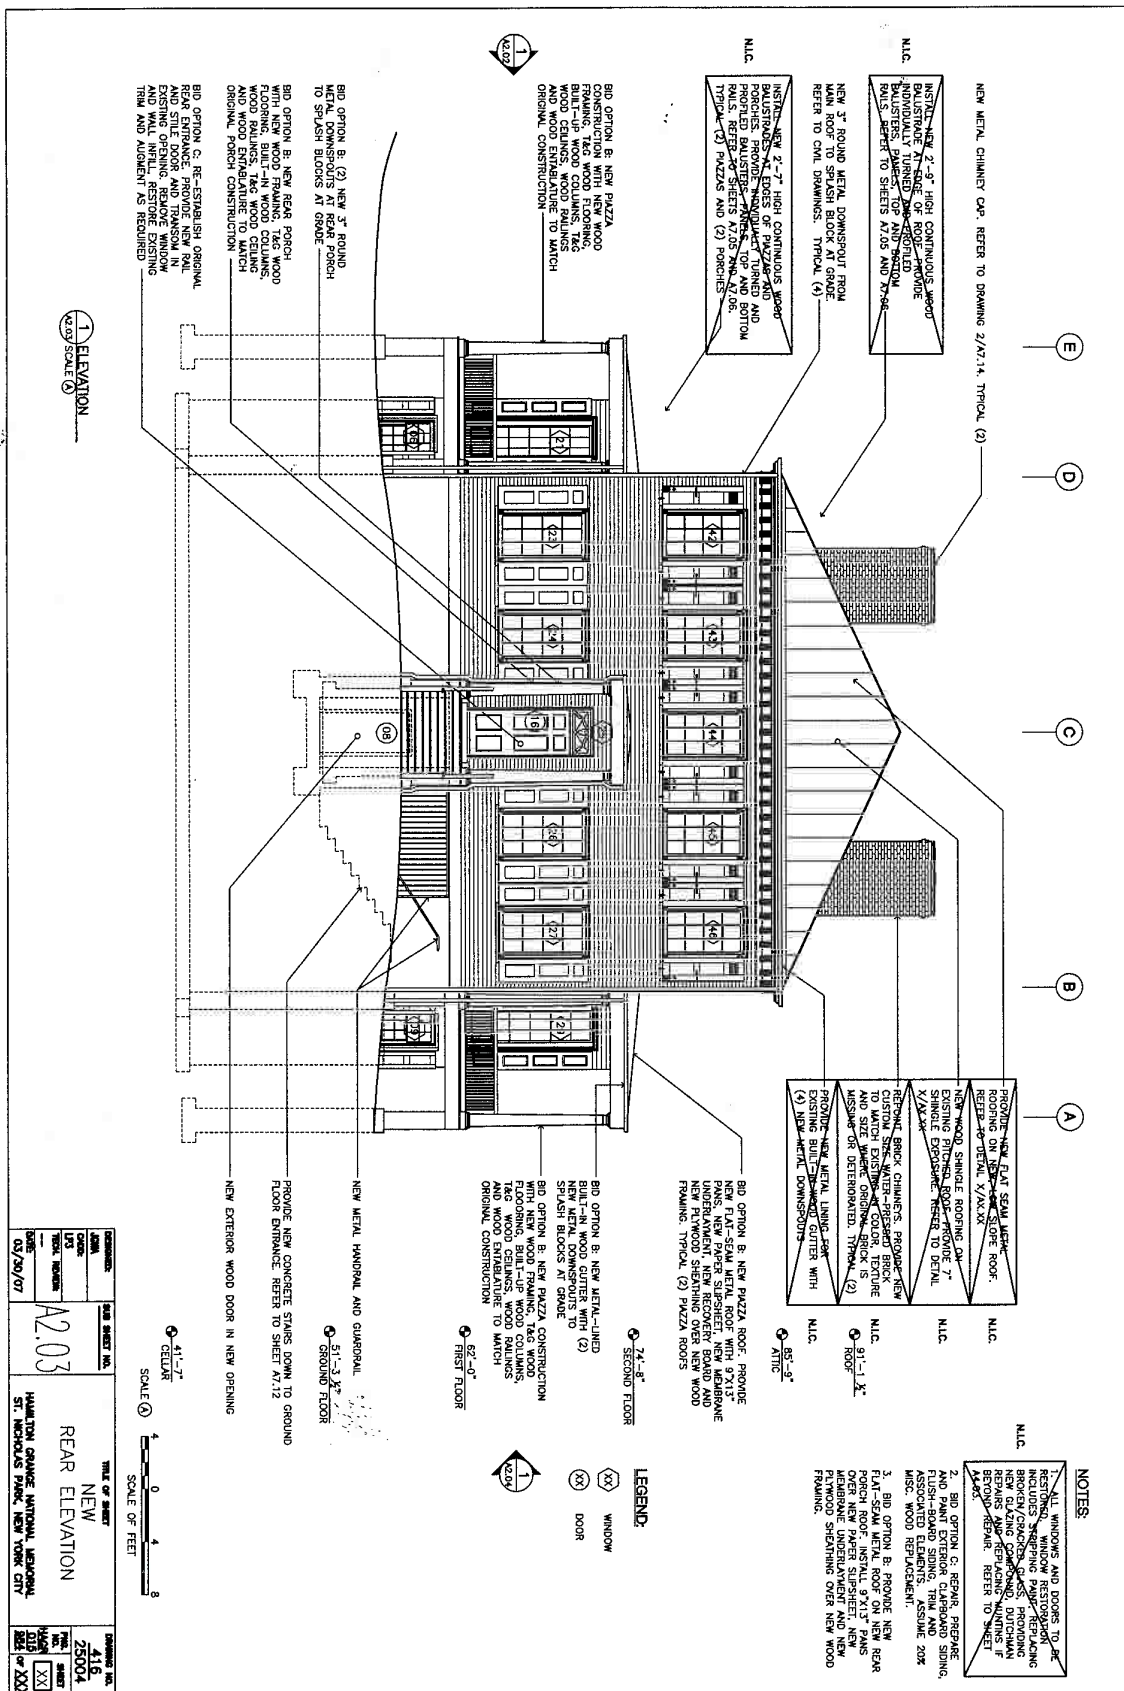
19. The lift cannot be moved to the Grange's rear porch for several reasons. The rear porch is too small to accommodate a lift without enlarging the structure or placing the lift along side of the porch. Either of those options alters the way the home would have appeared when it was built. Moreover, if the wheelchair lift were on the rear porch, the access for people with disabilities to the impressive visual presentation of the front of the Grange would be limited. Historic maps and historical accounts of the Grange indicate that visitors were meant to approach the front facade of the building, which is distinguished by its use of windows and siding, unlike the other sides of the building. NPS has designed access to the Grange so that all members of the public could have access to this aspect of the historic building. Construction documents showing architectural depictions of the front and rear of the home are attached as Exhibit 5. The front of the home is labeled USA 1 and the rear of the home is labeled USA 2.
